## CASE REPORT

# A novel technique to retrieve cold-welded implant abutment: A case series

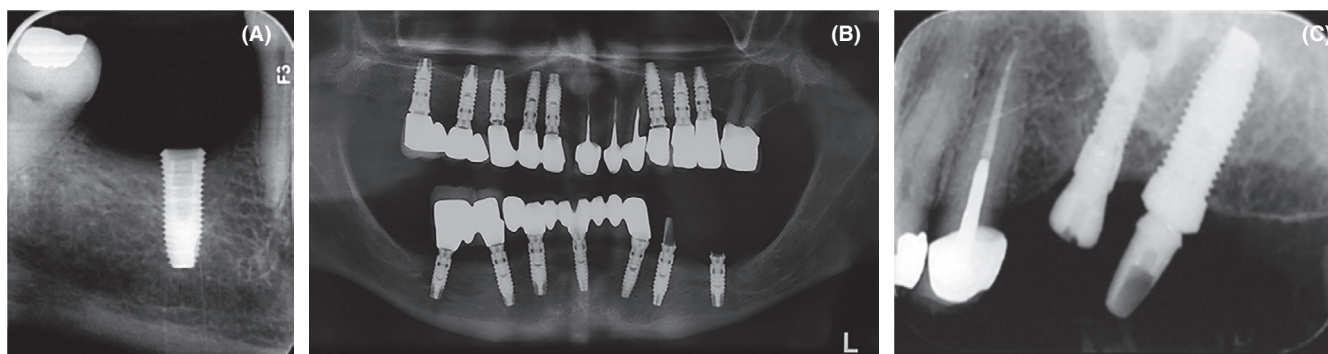
This clinical case series presents a new technique to retrieve cold-welded dental implant abutments. A number of patients who were referred to our clinic with the chief complaint of fracture of implant-supported fixed partial denture were evaluated. Clinical examination and taking patients' medical and dental history revealed that some patients had a history of heavy bruxism (which was obvious considering the occlusal wearing noticed in their clinical intraoral examination) and insufficient number of implants. Periapical radiographs were obtained to assess the fractured abutment and the condition of fixture. The broken abutments were observed on radiographs (Figure 1).

**FIGURE 1** A, B and C; Broken implant abutments observable on radiographs

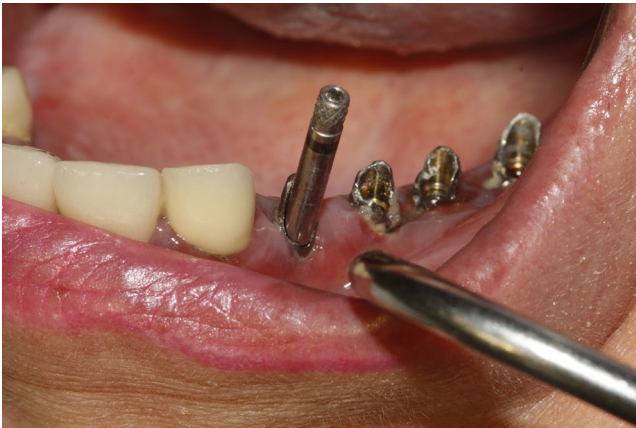
**FIGURE 2** Screwing a long impression coping into the abutment

following: First of all, the abutment screws were removed and then a long impression coping screw was placed on the abutments and screwed (Figure 2). Then, the arch crown hook was inclined horizontally to the screw and with applying few multidirectional strokes carried out in a very gentle manner, and the abutments were dislodged and easily removed. Glycerin was used as lubricant during the procedure (Figures 3 and 4).

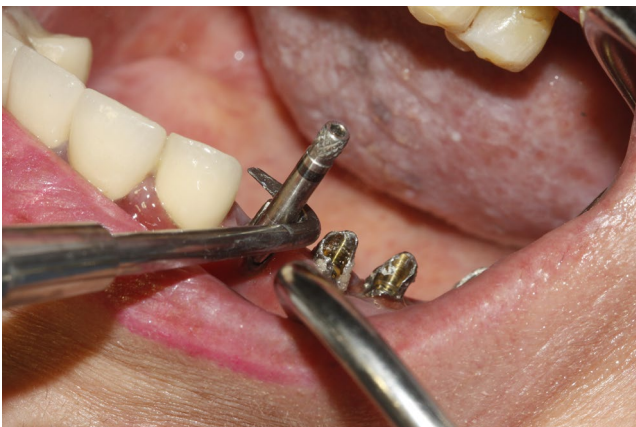
**FIGURE 3** Multidirectional strokes with crown removal

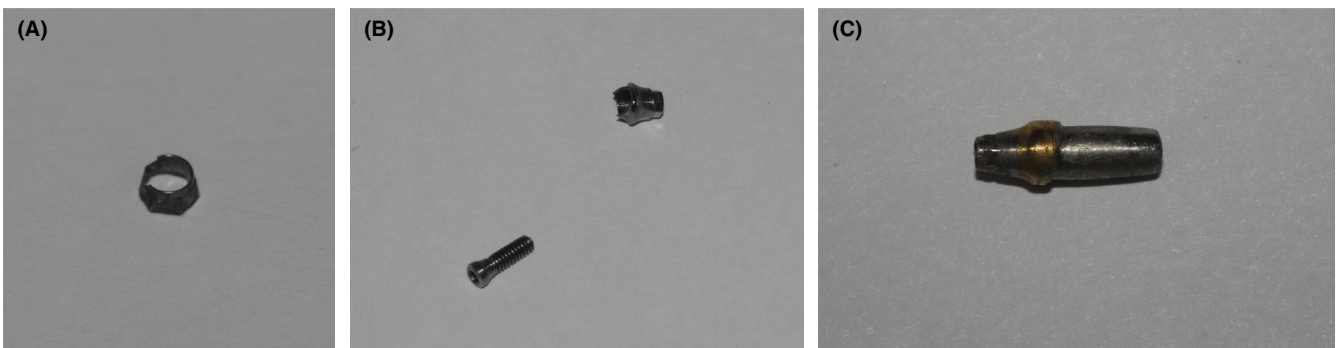
**FIGURE 4** A, B and C; Retrieved abutment hex
